Bartlett Consulting

Date: 29th August 2024
Our Reference: CW.240557.LR

RE: Updated Visual Tree Assessment 40 Guinea Street, Redcliffe, Bristol, BS1 6SX

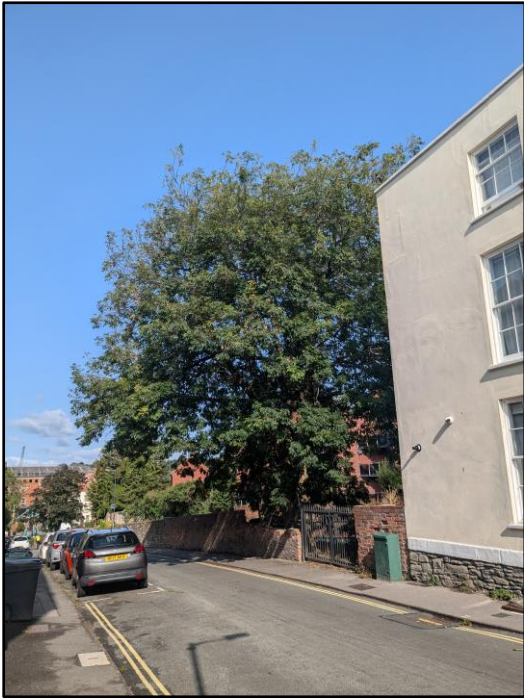
As the tree was in full leaf, it meant that a more accurate assessment of its health was possible during this assessment. The Ash had a full crown with good leaf coverage, as seen in figures 1, 2 and 3. The tree is exhibiting good vitality and I identified no signs of Ash Dieback within the tree's crown. The leaves and buds appear normal in appearance and density.

Figure 1: Image showing Ash in landscape viewed from east

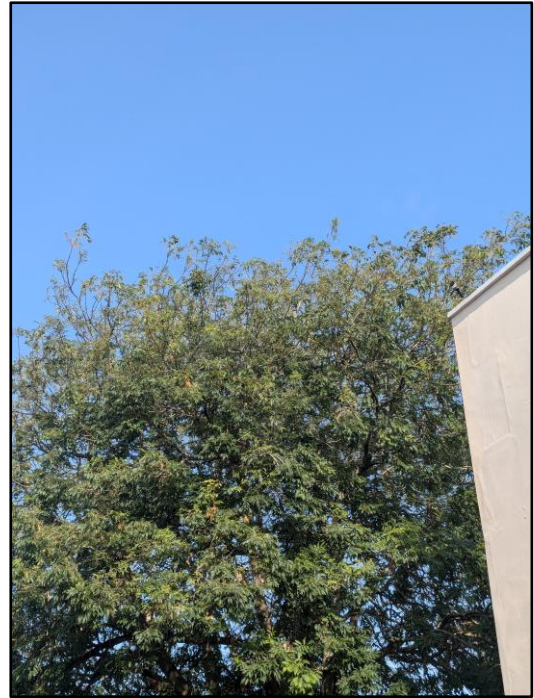
At present, I do not consider the tree to be affected by Ash Dieback.

Figure 2: Image showing crown with no signs of dieback, viewed from east

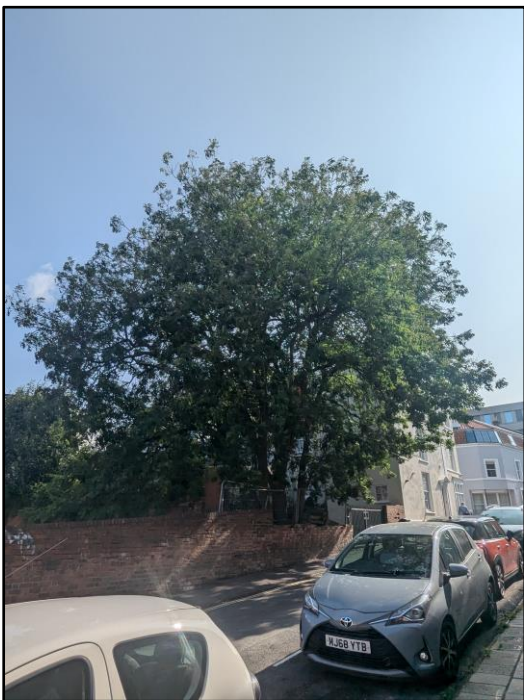
Figure 3: Image showing Ash, viewed from southwest

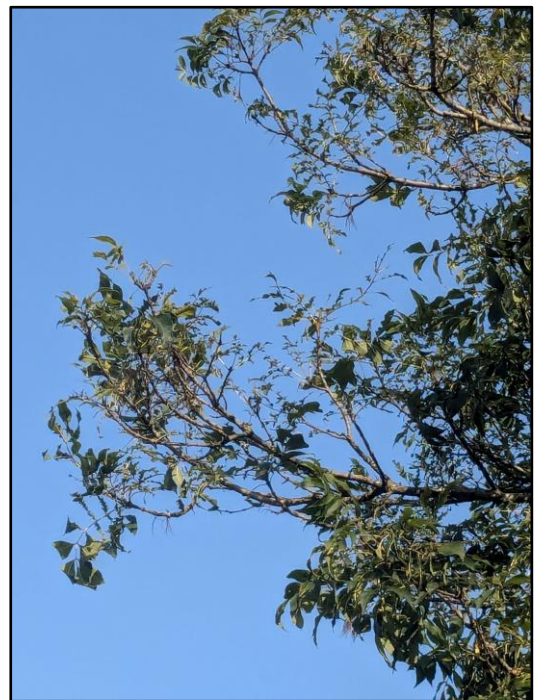
The newer leaves in the outer canopy have been eaten by pigeons. I do not consider this will have affected the tree's health and is a common occurrence that the tree will recover from.

Figure 4: Image showing new leaves eaten by pigeons
